## Customer Profile

St Clair Lodge

Vivian Bay, Kawau Island, New Zealand

Domestic water supply for St Clair Lodge

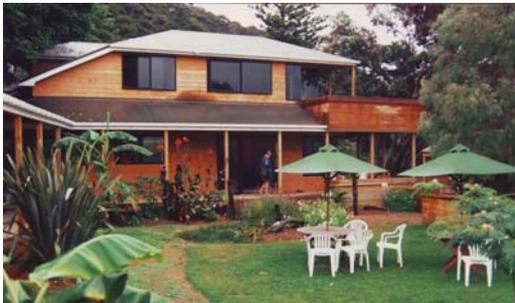
- Water Source:** Rain water, supplemented by bore water
- Storage capacity:** 5,000 gallon concrete tank (raw water)  
3,000 gallon fibre glass tank (treatment water)
- Daily usage:** About 2,500 litres (average)
- Equipment used:** Novozone 'skid-pack' water treatment system comprising of:
- Novozone CD-1000 corona discharge ozone generator
  - 1 HP Monster self priming pump
  - Mazzei 1-1/2" injector
  - 750 sqft cartridge filter

Because of the unavailability of a power supply at the storage tank, a site was prepared and a 3,000 gallon fibreglass tank (Ribtec) was placed beside a unit approximately half way down the hill, and this was set up as the ozone treatment tank. This tank was fed via a strainer (to remove organic debris) and ball cock, and the skid-pack was located alongside the unit, with the generator attached to the inside of the unit wall (to ensure dry conditions).

The suction was connected via the isolating valve and 40mm pipes to an outlet point near the bottom of the tank. The return line was plumbed in the top of the tank with a 45° elbow half way down to circulate the returning water in the tank.

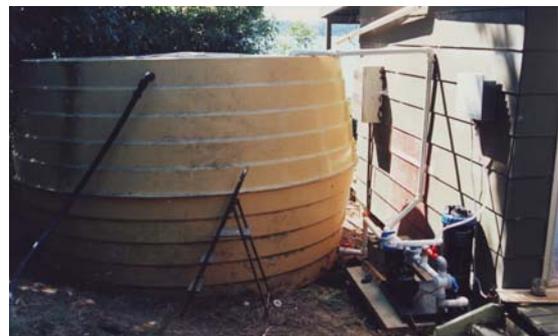
Novozone Ozone Generator  
Model CD-1000
